### **Arkema Facility - Harvey Response**

September 2, 2017

Project #109489 Summary

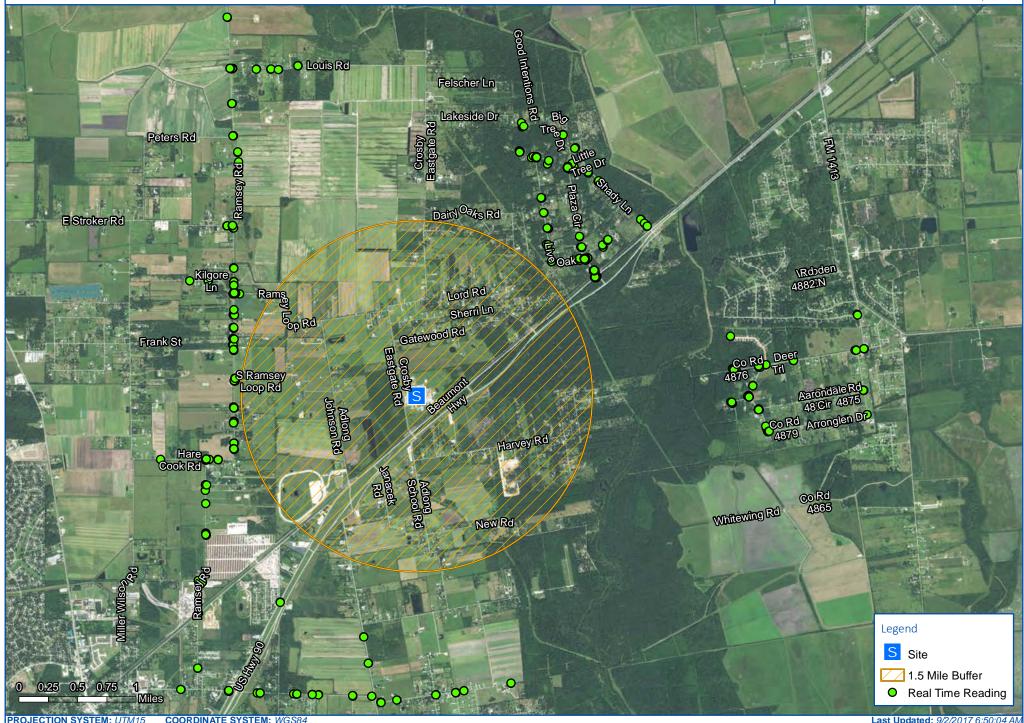
#### Hand-held Real-time Reading Locations

All real-time air monitoring instrumentation was calibrated per the manufacturer's recommendations prior to air monitoring. Handheld, real-time air monitoring was conducted for benzene, cumene, atmosphere flammability (lower explosive limit - LEL), and volatile organic compounds (VOCs) using RAE Systems and Gastec instruments. Additionally, combustion byproducts potentially associated with fire smoke, such as particulate matter (PM<sub>2.5</sub>), nitrogen dioxide (NO<sub>2</sub>) and sulfur dioxide (SO<sub>2</sub>) were assessed. **Table 1** summarizes the data for all real-time air monitoring readings recorded in Crosby, TX from 06:00 on September 1, 2017 through 06:00 on September 2, 2017. Maps of real-time air monitoring locations are provided as **Attachment B**.

Harvey Response - 06:00 September 1, 2017 to 06:00 September 2, 2017

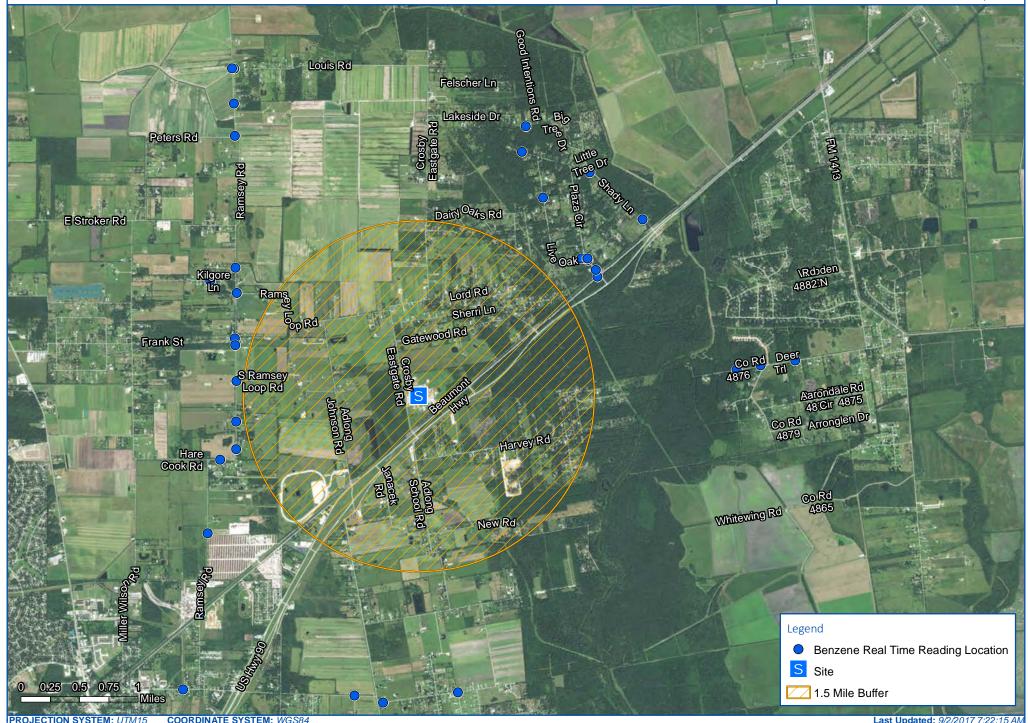
#### Benzene Hand-held Real-time Reading Locations

Harvey Response - 06:00 September 1, 2017 to 06:00 September 2, 2017

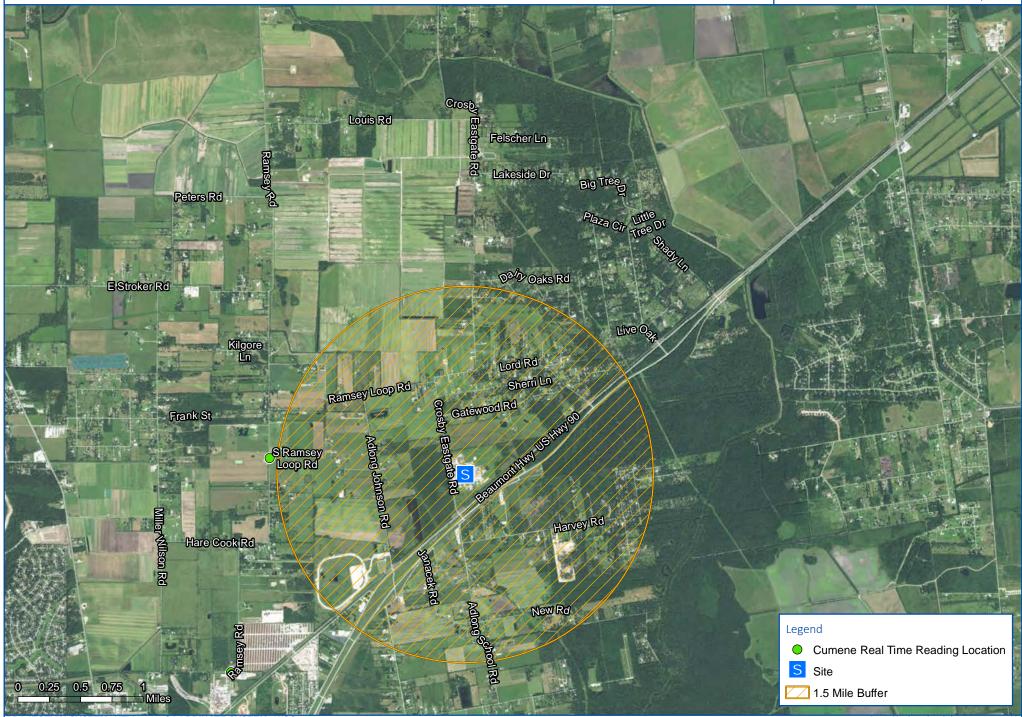
#### Cumene Hand-held Real-time Reading Locations

Harvey Response - 06:00 September 1, 2017 to 06:00 September 2, 2017

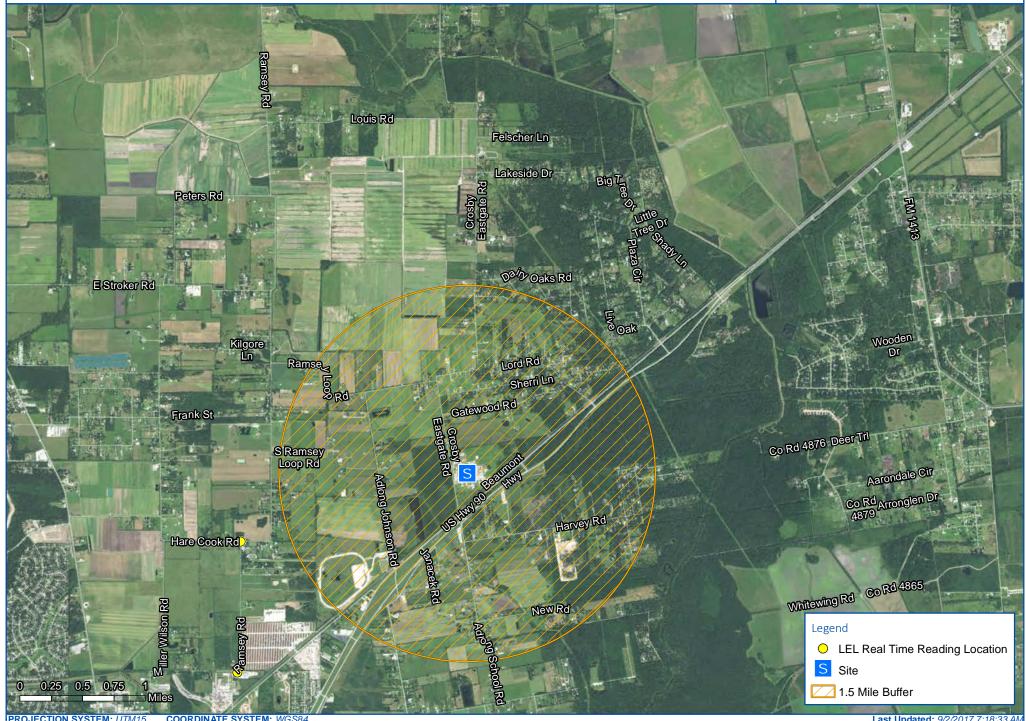
#### LEL Hand-held Real-time Reading Locations

Harvey Response - 06:00 September 1, 2017 to 06:00 September 2, 2017

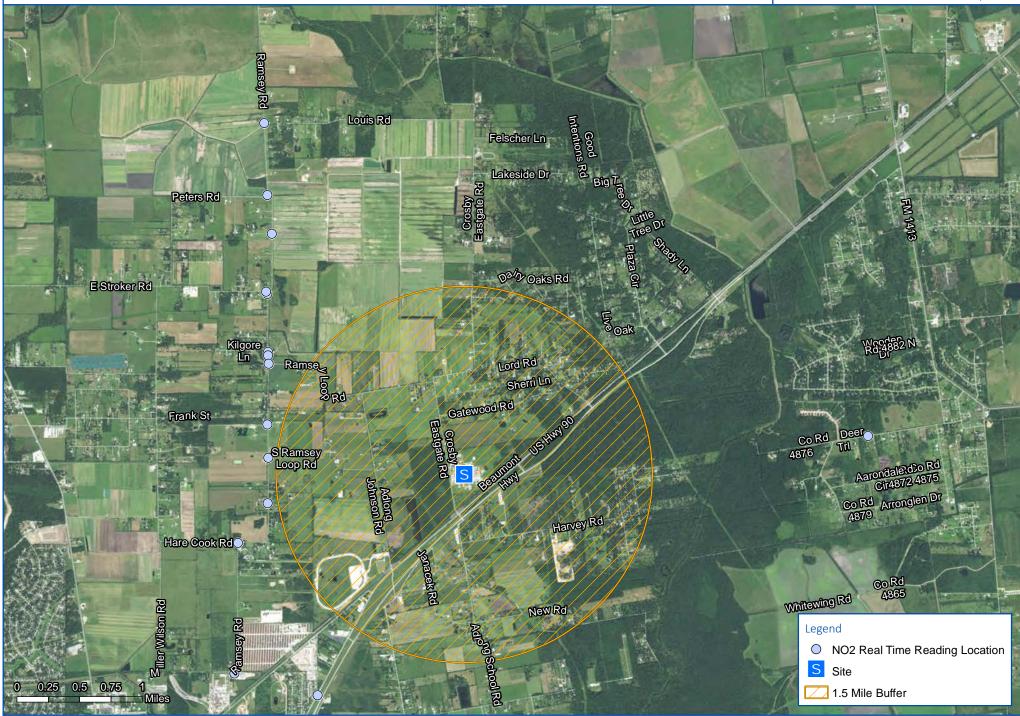
#### Nitrogen Dioxide Hand-held Real-time Reading Locations

Harvey Response - 06:00 September 1, 2017 to 06:00 September 2, 2017

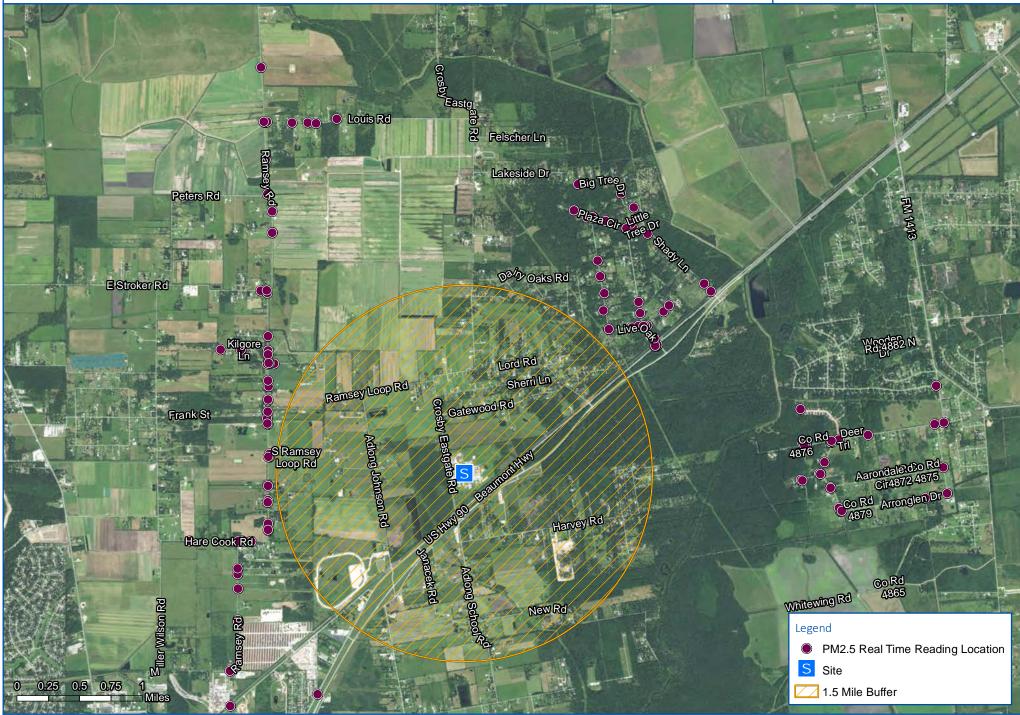
#### PM2.5 Hand-held Real-time Reading Locations

Harvey Response - 06:00 September 1, 2017 to 06:00 September 2, 2017

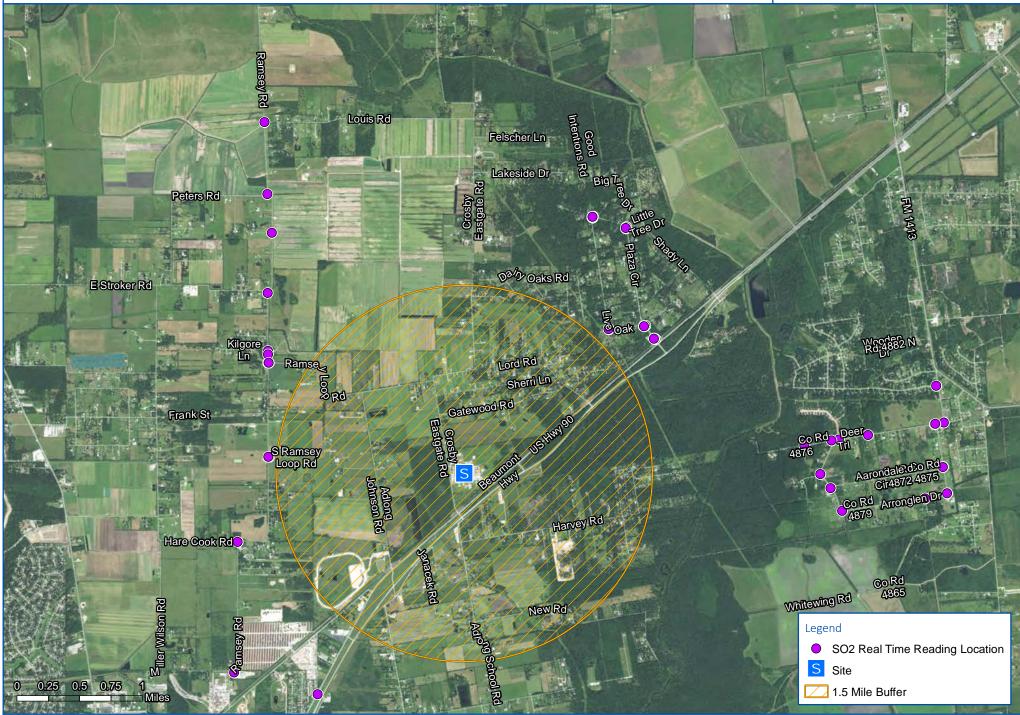
#### Sulfur Dioxide Hand-held Real-time Reading Locations

Harvey Response - 06:00 September 1, 2017 to 06:00 September 2, 2017

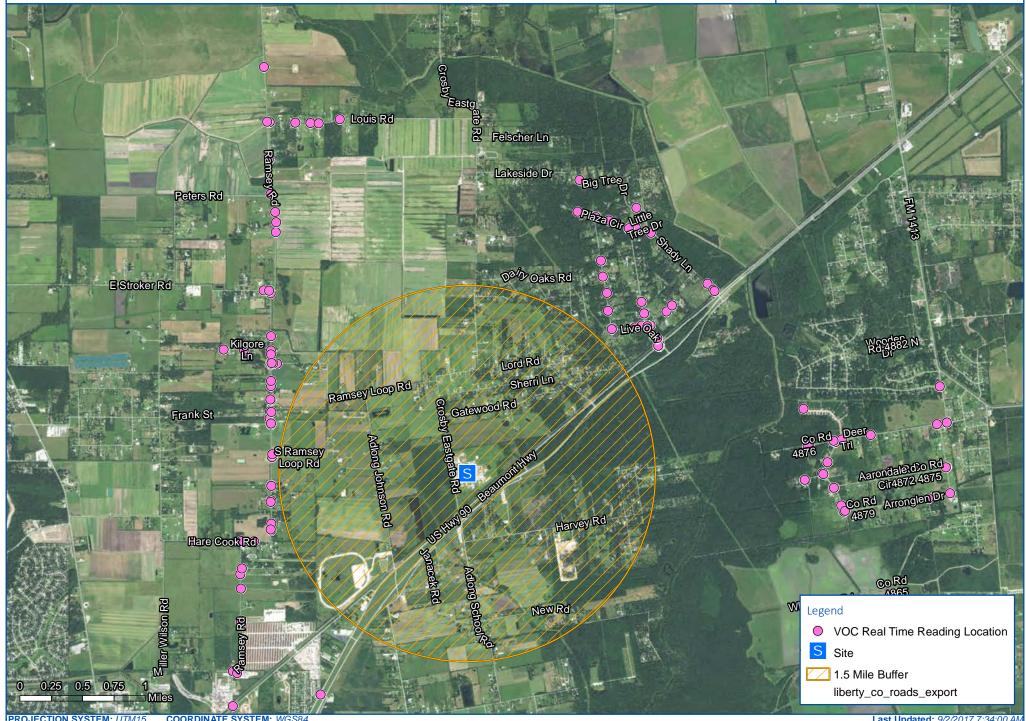
#### VOC Hand-held Real-time Reading Locations

Harvey Response - 06:00 September 1, 2017 to 06:00 September 2, 2017

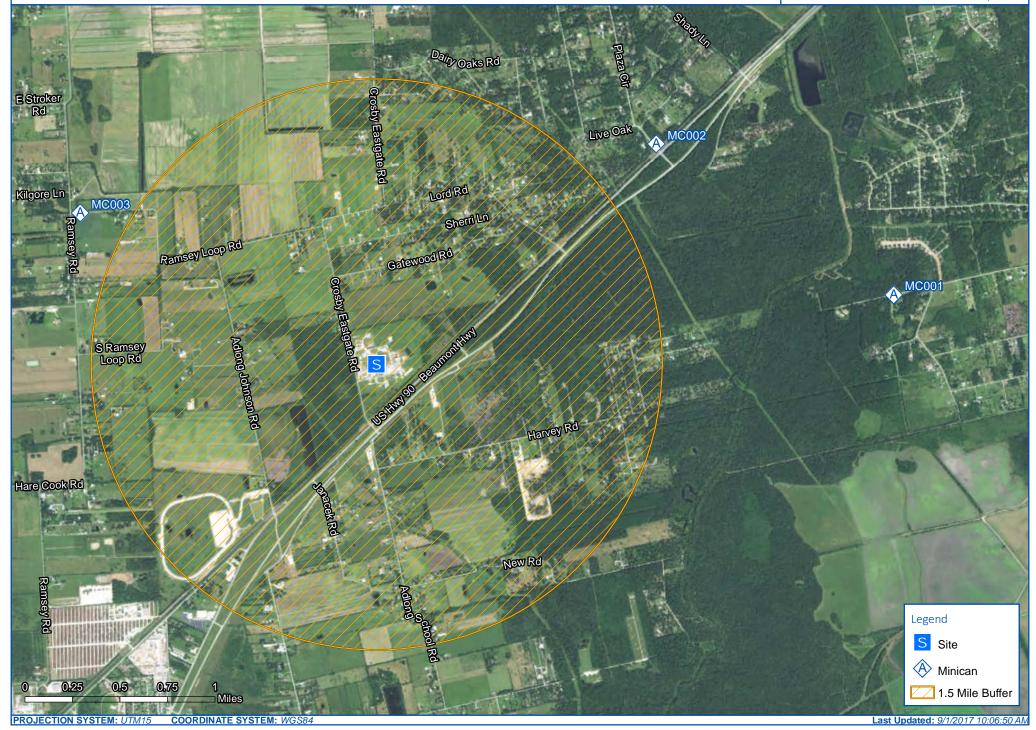
### **Analytical Air Monitoring Station Locations**

To supplement real-time air monitoring, CTEH® deployed areas along the perimeter of the evacuated area within the community. Evacuated canister (Minican™) samplers were regulated to collect air evenly over a 24-hr period. Analytical air samples will be submitted to SGS Galson Laboratories, an AIHA-accredited laboratory, for analysis using EPA Method TO-15. A map highlighting the analytical air sampling locations is provided as **Attachment C**. Analytical Air Sampling Results will be reported upon receipt from the laboratory.

Harvey Response - August 31, 2017

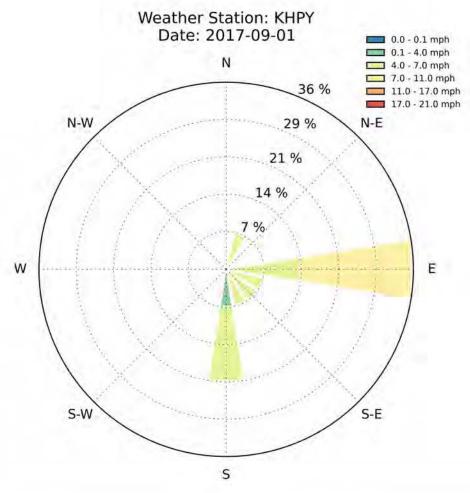
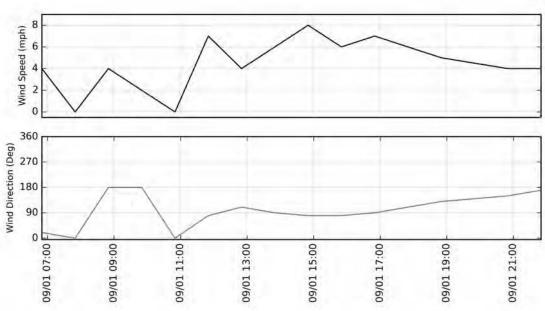
### Attachment D KHPY Windrose

(Highland Park Airport - 12.5 miles SSE of Site)
